# Manhole Inspection Summary

Manhole # S49AA\_041MH

Insp Date: **3/9/10 1:31 PM**

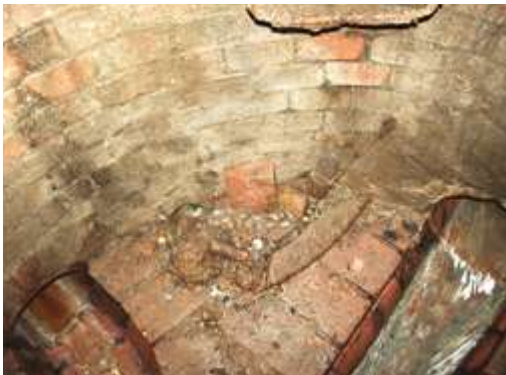
Defect 3

debris

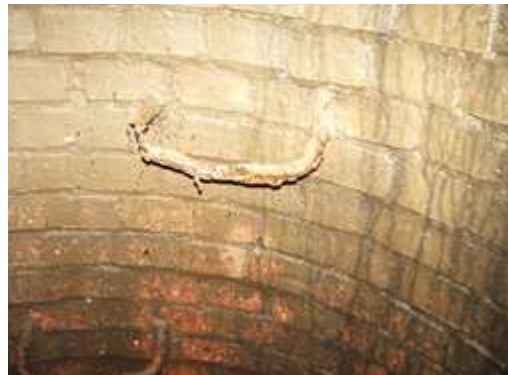
Defect 2

Count: **4** Missing: **2** ☐ Corroded

stairs

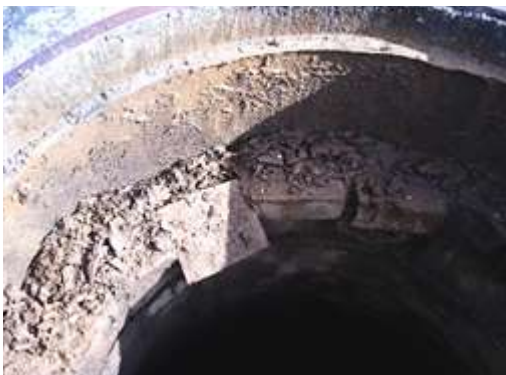
Defect 1

Condition: ☐ Sound ☐ Cracked ☐ Root Intrusion ☒ **Loose Brick** ☒ **Deteriorated**

loose bricks

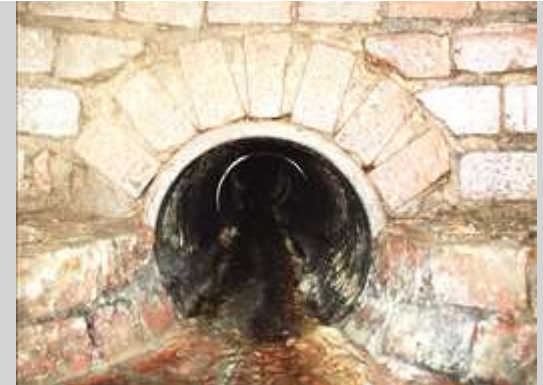
12 O'Clock Outflow

10 in. Circular Gravity Sewer  
Pipe Out @ 12 O'Clock

Pipe Height: **14.4** (in.) Rod and Bar (Angled)  
Pipe Material: **Clay** ☐ Pipe Lined  
Invert Depth: **12.08** (ft.) Flow Characteristics: **Fast**  
Deposits: ☒ None ☐ Mud ☐ Sludge ☐ Debris ☐ Grease  
Silt Depth: (in.) Deposits Extent:  
Infiltration: **None** Pipe Seal Cond: **Sound**

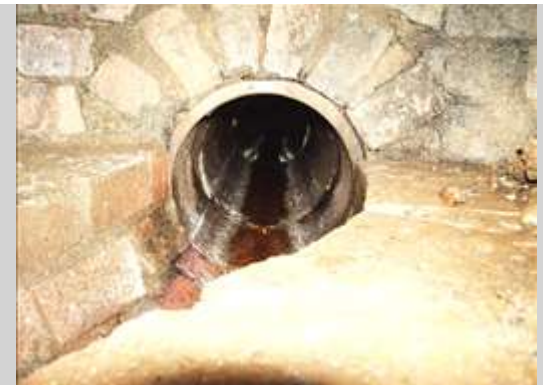
3 O'Clock Inflow

8 in. Circular Gravity Sewer  
Pipe In @ 3 O'Clock

Pipe Height: **12** (in.) Rod and Bar (Angled)  
Pipe Material: **Clay** ☐ Pipe Lined  
Invert Depth: **11.75** (ft.) Flow Characteristics: **Fast**  
Deposits: ☒ None ☐ Mud ☐ Sludge ☐ Debris ☐ Grease  
Silt Depth: (in.) Deposits Extent:  
Infiltration: **None** Pipe Seal Cond: **Sound**

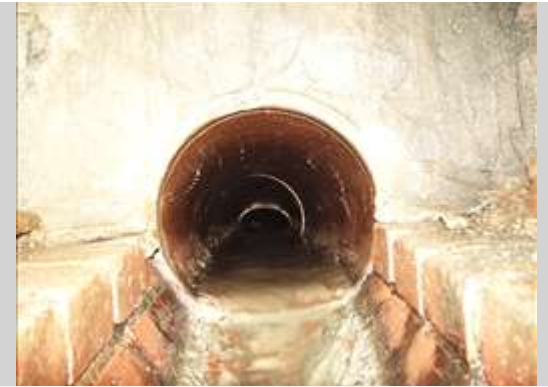
6 O'Clock Inflow

10 in. Circular Gravity Sewer

Pipe In @ 6 O'Clock

Pipe Height: **26.4** (in.) Rod and Bar (Angled)

Infiltration: **None** Pipe Seal Cond: **Sound**

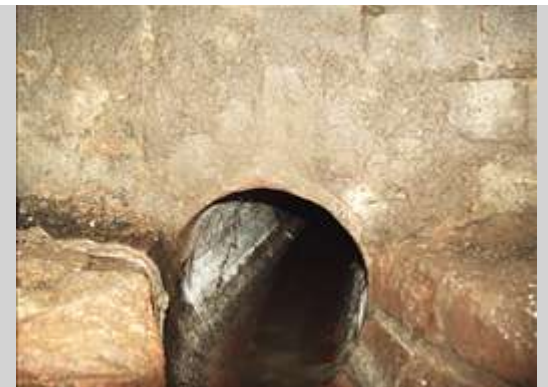
9 O'Clock Inflow

8 in. Circular Gravity Sewer

Pipe In @ 9 O'Clock

Pipe Height: **12** (in.) Rod and Bar (Angled)

Infiltration: **None** Pipe Seal Cond: **Sound**
